**Architectural Impact Assessment of dwellings on  
portion 9 of the farm La Mercy 15124 for Dube  
Tradeport Corporation**

**Prepared for: Dube Tradeport Corporation  
15th floor, Marine Building  
22 Gardiner Street  
Durban**

# **Architectural Impact Assessment of dwellings on portion of 9 the farm La Mercy 15124 for Dube Tradeport Corporation**

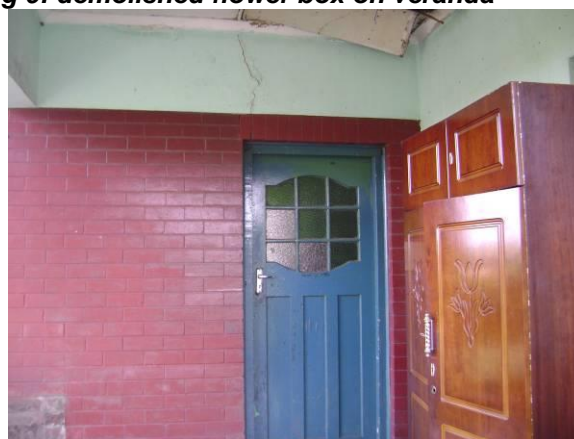
**Fig 11: View of front door**

*Recommendations: There is little diagnostic evidence to suggest that any part of this building is over 60 years of age. However, it is strongly considered that the wood-and-iron kitchen behind it, which has been recently demolished for removal to Tongaat, dates back to the early years of the last century, with the settlement of the indentured Indians. Recent lack of maintenance and isolation make scant case for retaining this building once it is evacuated. It is recommended that demolition be allowed.*

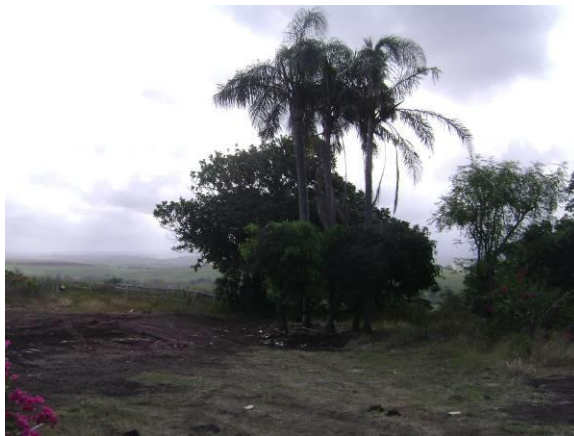
**Fig 27: Site in March 2011**

*Recommendations: This house was an example of a vernacular dwelling common to the Canefields area, of which many more exist. Its condition appeared to have been reasonable. As with House 1 above, isolation would have made scant case for retaining this building once it was evacuated. Demolition, had it been sought, would have been recommended as an option.*

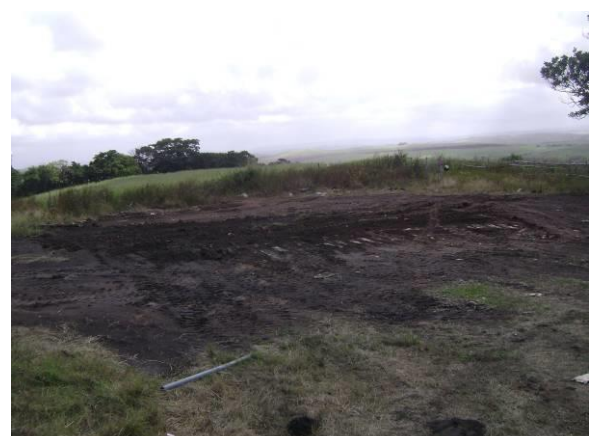
**Fig 28: Site in March 2011**
